32nd International Conference on Ground Control in Mining

Influence of Mine Layout, Mining Method, and Geology on Down-Dip Coal Barrier Performance at the Solar No. 7 Mine

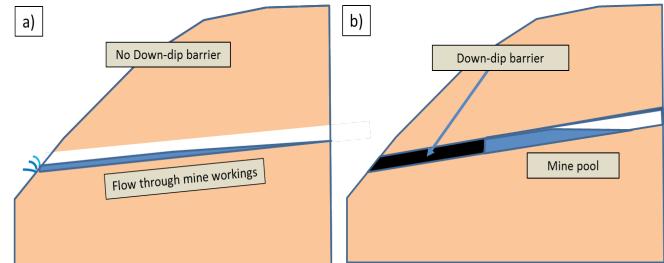
Figure 1. a) Typical scenarios for legacy underground coal mines where mining developed from the drift area and moved up-dip allowing water to move away from the working faces. b) Post-SMCRA, where mining established a down-dip coal barrier to contain the mine pool and eliminate drainage.

Most legacy drift mines (mines operated prior to the 1970s) entered the coal reserve from outcrop and developed up-dip. This was the preferred mining method because water entering the mine would move away from the working faces, minimizing problems during production (Figure 1a). Unfortunately, this mining technique can negatively impact the quality of water moving through it. When mine water comes in contact with strata rich in iron,

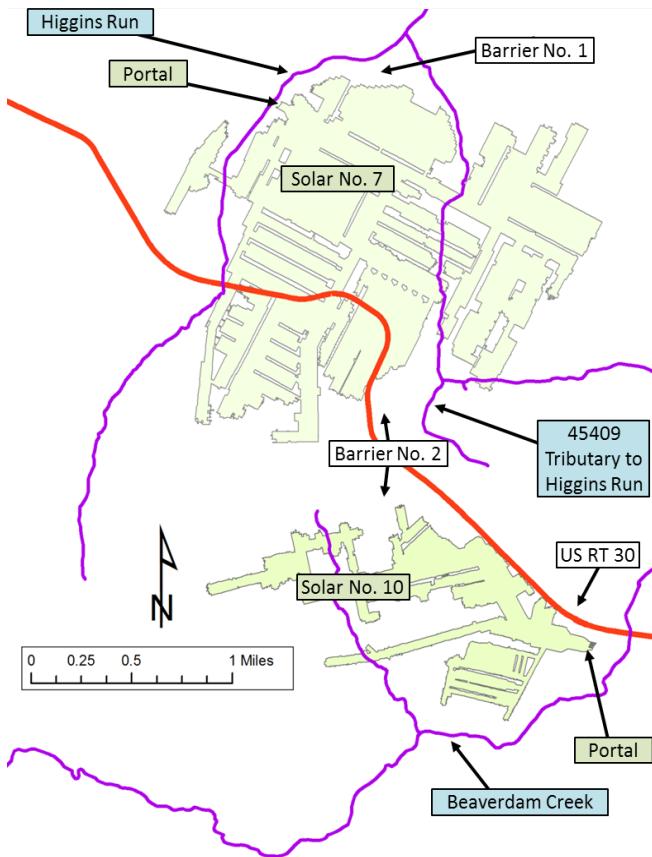
Figure 2. a) Locations of the Solar No. 7 and Solar No. 10 mines. The positions of the major streams, U.S. Route 30, mine portals, and down-dip barriers (No. 1 and No. 2) are also shown.

The Solar No.7 and Solar No. 10 room-and-pillar underground coal mines are located in northern Somerset County, Pennsylvania, near U.S. Route 30 (Figure 2). The Upper Kittanning coalbed in this area is 4 to 5-ft thick and overlain by shales and sandstones.

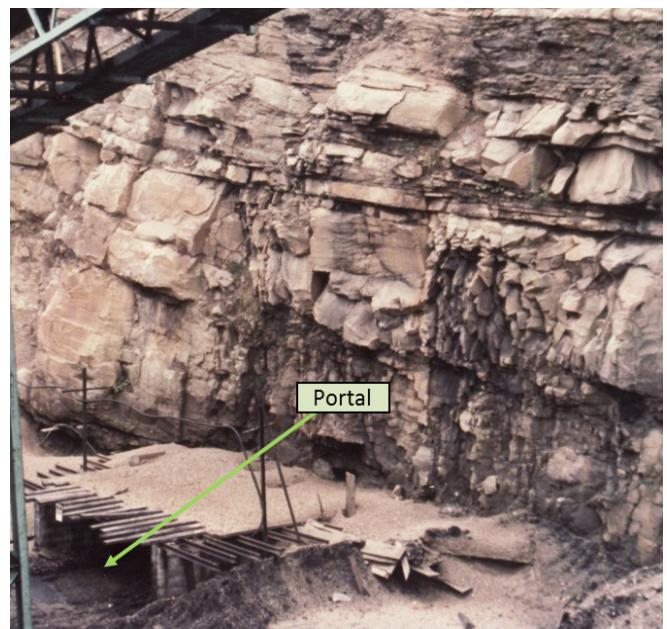
Figure 3. Photograph of the Solar No. 7 portal area showing the thick, massive sandstone roof rock.

The coalbed is underlain by claystones and the Johnstown limestone. Thick sandstone overlies the main entries near the Solar No. 7 portals (Figure 3). The Solar No. 7 mine was opened in 1975 by Lunar Mining, Inc. followed by Solar No. 10 in 1976 by Solar Fuel Company Inc. Both mines were purchased and sold to a number of different companies during their working lives. The Solar No. 7 mine was operated by Genesis Inc. at the time of its closing in 2002. Currently, Rosebud Mining Co. owns the mine property. The Solar No. 10 was owned by Solar Fuel Company Inc. at the time of its closing in 2002 and is the current owner of the mine property.

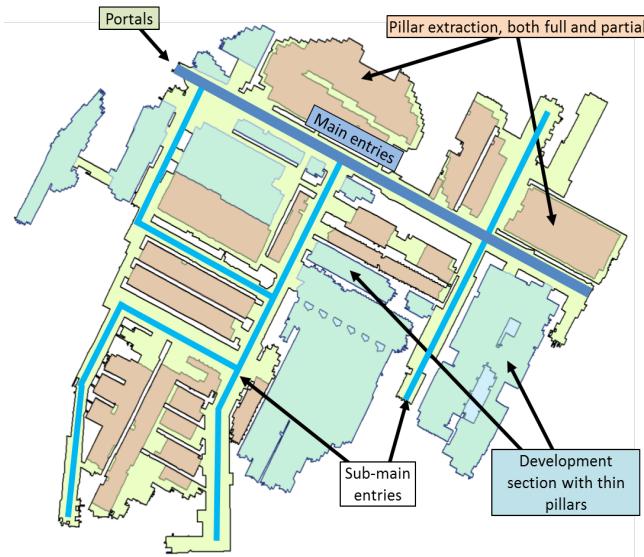
Figure 4. Mining methods used at the Solar No. 7 mine included multiple entry room-and-pillar main and sub-main entries with attached production panels.

Solar No. 7 and Solar No. 10 are room-and-pillar mines. Development panels were sometimes subjected to either full or partial pillar recovery. Figure 4 shows the mine layout of the Solar No. 7 mine with the outlines of full and partial pillar recovery areas. Pillars within full extraction sections are recovered, leaving only remnants of coal acting as a temporary roof support. The immediate roof in these areas was allowed to fail, filling the sections with broken rock and forming gob. In areas where partial pillar recovery occurred, portions of the pillars were left in place. Lastly, a significant amount of the production sections in the southeastern portion of the mine were developed using thin pillars (Figure 4). Most of the pillars in these sections are less than 30-

noted that mining sections within the Solar No. 7 and Solar No. 10 mines near this Stoystown coal barrier were developed with a combination of thin pillars and full pillar extraction mining methods (Figure 4).

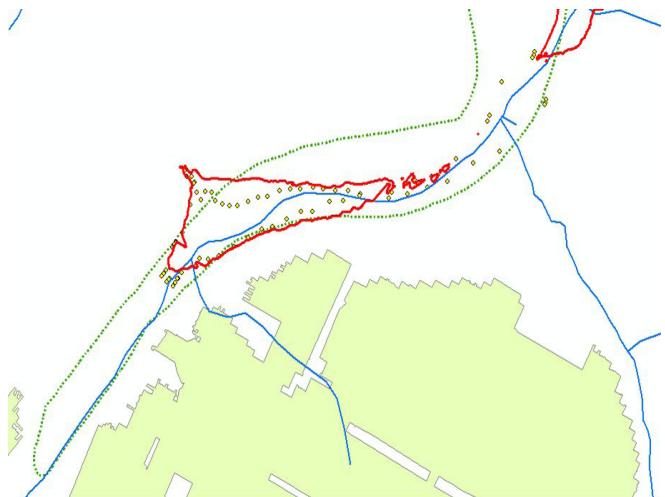
Figure 6. Three examples of the Upper Kittanning coalbed outcrop lines along Higgins Run, each dependent on a unique structure contour map.

A precise understanding of the structure contours for the Upper Kittanning coalbed is needed to accurately determine the coal outcrop along the Higgins Run down-dip barrier (Figure 6). The authors developed information on three different Upper Kittanning coalbed outcrop lines:

- Dashed line: Outcrop line drawn on the mine's 6-month mining map.

- Dots: Outcrop line drawn from intersection of the structure contours from the Pennsylvania (PA) Geological Survey data with their equivalent surface lines (from the LIDAR 2-ft surface contour maps provided by the PA Geological Survey).
- Solid line: Outcrop line drawn from the intersection of the structure contours from the in-mine survey points with their equivalent surface lines (again from LIDAR 2-ft surface contours).

These three outcrop lines each present a slightly different view of the barrier size along Higgins Run. The most accurate outcrop line comes from the in-mine survey data and is used throughout the remainder of the report. The authors wanted to present this analysis to illustrate the complexity of establishing the position of the coal outcrop. This position can affect the barrier width estimates.

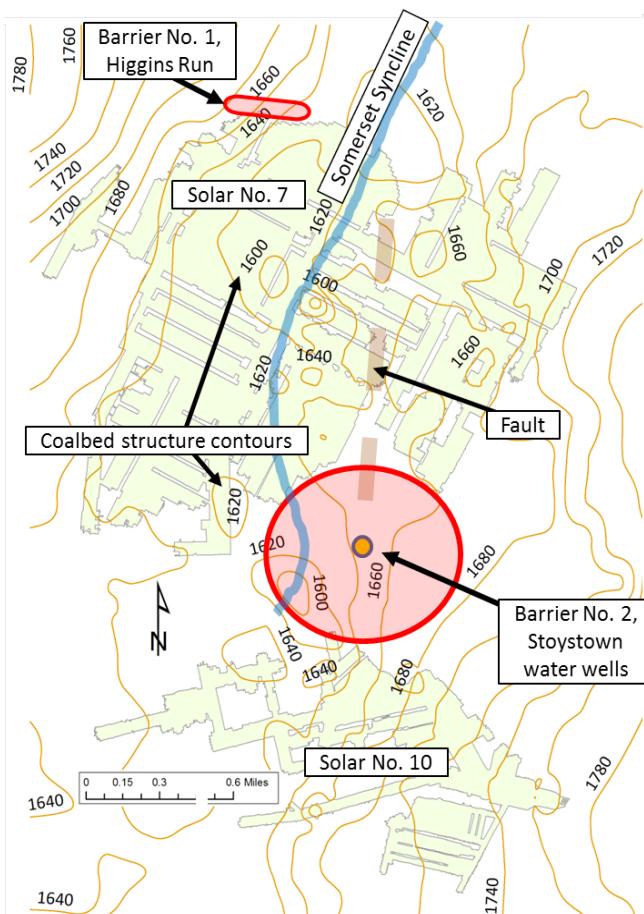
Figure 5. Upper Kittanning coalbed structure contour map constructed from numerous in-mine survey points. Also shown are the location of the down-dip barriers studied in this report. (No. 1 and No. 2).

The Upper Kittanning coalbed at the Solar No. 7 and Solar No. 10 mines lies within the Somerset Syncline where the structure contour elevations are approximately 1,600-ft and gently rise 2° to 4° to the Boswell Dome in the northwest and the Negro Mountain Anticline in the southeast. A detailed structure contour map was constructed from the hundreds of survey contained on the mine's official maps (Figure 5). The locations of Barrier No. 1, along Higgins Run, and Barrier No. 2, protecting the Stoystown municipal water supply wells, are also shown.

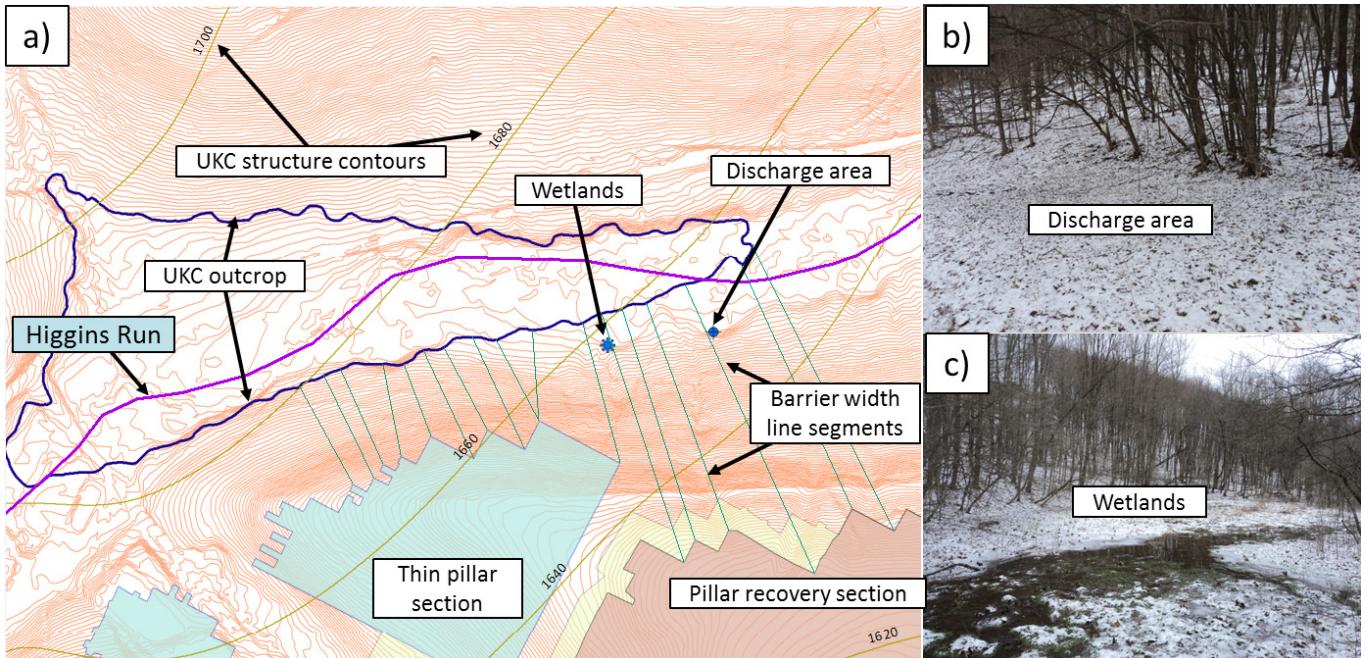
Figure 7. a) Plan view showing the mine layout, Upper Kittanning coalbed outcrop line and structure contours, Higgins Run, discharge area, and adjacent wetlands. b) Photograph of the discharge area. c) Photograph of the adjacent wetlands.

In the winter of 2004, PA DEP agents first noted a ‘yellow’ discharge indicative of iron rich waters from the hillside along Higgins Run (Figure 7a). The surface discharge occurred when the mine pool reached its highest elevation of 1,681-ft. The discharge occurred in a relatively narrow zone ranging between 10 and 40-ft in width. The length of the down-dip barrier from the 1,680-ft contour (maximum pool elevation) to the eastern end of the projected Upper Kittanning coalbed outcrop is measured to be approximately 1,400-ft. The average width of the barrier was calculated from 16 line segments, and it averages 456-ft (Figure 7). The elevation at the discharge point is approximately 1,660-ft, producing a hydraulic head of approximately 20-ft. The estimated discharge rate was 30 to 75-gpm.

All of the reported discharges occurred within a narrow area (Figure 7b). It is interesting to note that a wetlands, approximately 100-yards to the west of the discharge point, did not show any signs of contamination from mine water (Figure 7c). At this point in time, the mine operator began to pump and treat water from

An estimated discharge rate of 30 to 75-gpm occurred at one location (Figure 7) along the 1,400-ft barrier (Barrier No.1). Potential causes for the high hydraulic conductivity values could be due to the presence of fractures and bedding planes surrounding the coal barrier. These features are mainly geologic in origin, although full extraction mining can deform, or even induce, their occurrence. Iannacchione, et al. (1981) found that joints, coal cleat, and slickensided planes all had prominent clustering of N 17° W, N 72° W, N 48° E, N 62° E, and N 74° E. The latter three orientations are sub-parallel to the shortest distance from the yield pillar and full extraction pillar sections to the discharge point along Higgins Run.

The most general case to consider is a single weathered fracture extending vertically from the coalbed to the surface (range of 10 to 100-ft) and connecting the Solar No. 7 mine pool with the discharge point (Figure 7) along a N 60° E trendline. This case can be modeled using an approach developed by Romm (1966).

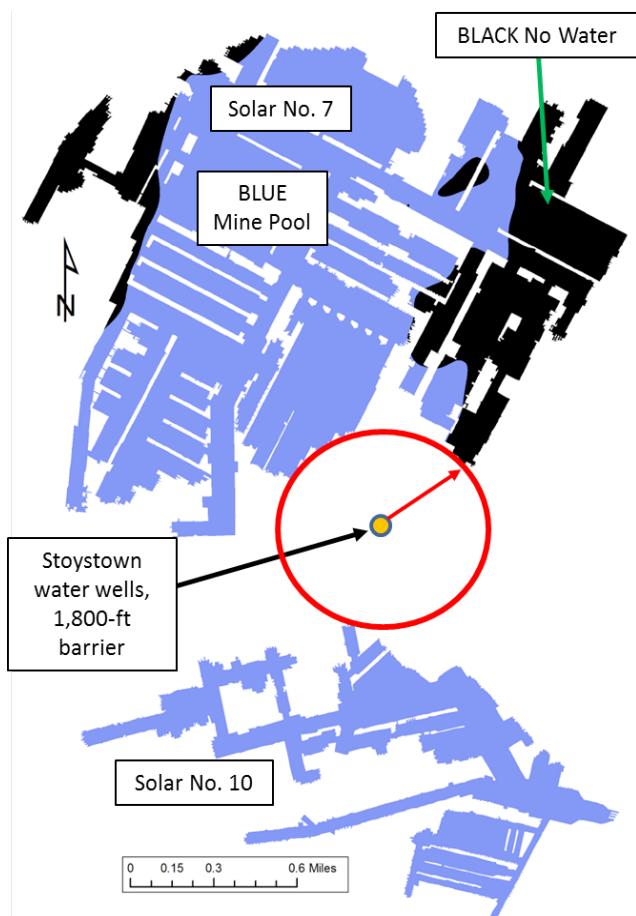
Figure 8. Location of the Stoystown municipal water wells with the 1,800-ft coal barrier. The water level for the Solar No. 7 mine pool is 1,655-ft and 1,765-ft for the Solar No. 10 mine pool. Also note the location of the fault that could be partially responsible for the productivity of these wells.

The Solar No. 7 and Solar No. 10 mines are adjacent to the Stoystown municipal water supply. Stoystown, Pennsylvania, has four water wells producing directly from the Upper Kittanning coalbed and the underlying Johnstown limestone and Kittanning sandstone (Figure 8). These water wells were drilled in a valley and average approximately 200-ft in depth. The overburden above Barrier No. 2 ranges from slightly less than 200-ft to greater than 400-ft. Under these conditions, fractures should be relatively narrow (low aperture width). A potential source of this water reservoir is thought to be a fault that crosses the Solar No. 7 mine from north-to-south (Iannacchione, et al., 1981) and intersects the area containing the Stoystown water wells (Figure 5). This fault was observed underground to contain numerous open fractures and bedding planes (Figure 9).

The no-mining coal reserve had a radius of 1,800-ft and, in this location, constitutes a down-dip barrier (Barrier No. 2). Most of themine sections around the perimeter of this reserve are filled with water. The elevation of the Upper Kittanning coalbed at the water wells is approximately 1,645-ft. If the Solar No. 7 mine pool was at 1,655-ft, only a 10-ft hydraulic head would have been present. When the Solar No. 10 mine is flooded to its portal, an elevation of approximately 1,765-ft is achieved. This would produce a maximum hydraulic head of approximately 120-ft. It should be

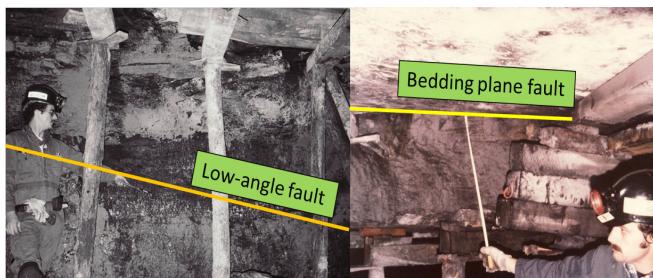
Figure 9. Photographs of faults observed within the Solar No. 7 mine. These faults are projected to intercept the Stoystown water supply wells.
